Experimental Study on Corrosion Mechanism in Guangli Oilfield

ZHANG Lei^{[a],*}

^[a] Institute of Drilling Technology, Shengli Petroleum Engineering Co., Ltd, Sinopec, Dongying, China.

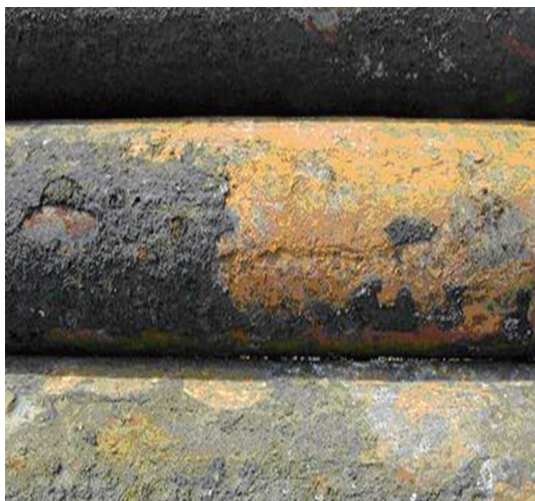
The conformation of casing corrosion is shown in Figures 1 to 3. Casing corrosion has the following characteristics: (a) The corrosion fouling in outer layer of the casing wall is easy to fall off, its color is black and the thickness is 2-3 mm, and the inner layer of the casing wall is made up of rust material with different sizes, which indicates acute local corrosion (Figure 1). (b) There is even corrosion fouling covering the inner wall of the casing, its color is tawny and the thickness is 1-2 mm and it is not likely to fall off, the inner wall is characterized by local potholes corrosion (Figure 2). (c) Some of the exterior surface of the casing is eroded by superficial water or even punched (Figure 3) and it can

Figure 1
External Corrosion of Casing

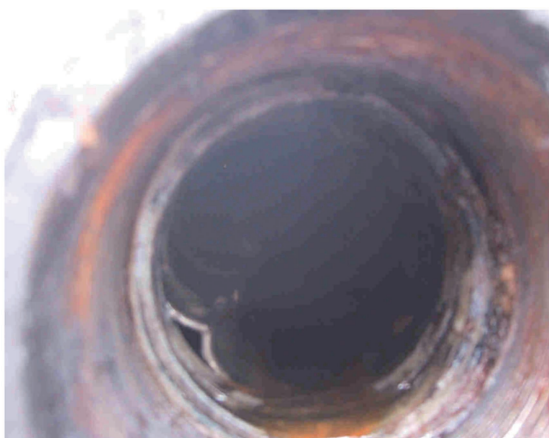
Figure 2
Internal Corrosion of Casing

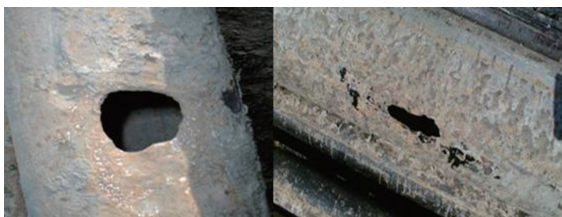
occur in just 8 months since its putting into production, which directly affected the normal operation of the oilfield and its safety.

Figure 3
Casing Corrosion Punching

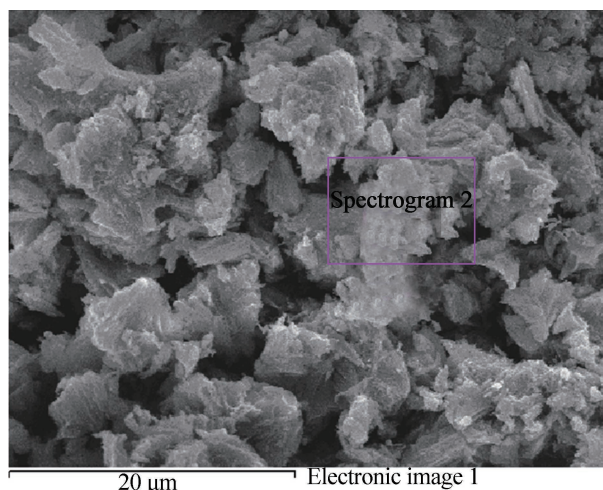
Figure 4
SEM Picture of Corrosion Fouling of 10 m Depth

It can be seen from Figure 4 that corrosion fouling is likely to fall off. SEM observation indicates that the product of corrosion mainly contains 3 elements: O, Fe and Cl. The reason for the casing corrosion of 10m depth is thought to be the electrochemical erosion initiated by Cl^- , and its mechanism is shown as follows:

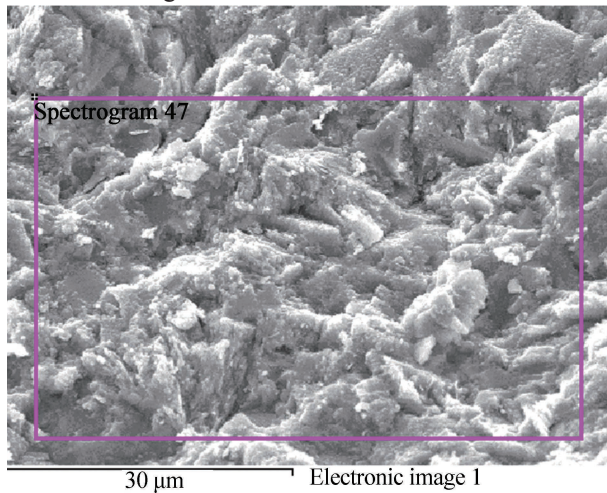
Figure 5
SEM Picture of Corrosion Fouling of 100 m Depth

The results show that the main element in the corrosion fouling is O and C, Fe and Cl followed. XRD analysis spectrum is adopted, and it can be analyzed that the corrosion products are mainly FeCO_3 , $\text{Fe}_2(\text{OH})_3$, $\text{Fe}_2\text{O}_3 \cdot n\text{H}_2\text{O}$, which is shown in Figure 6. So we can safely come to the conclusion that the main reason for the casing corrosion of 100 m depth is oxygen corrosion and carbon dioxide corrosion, and the existing of Cl^- increases the corrosion.

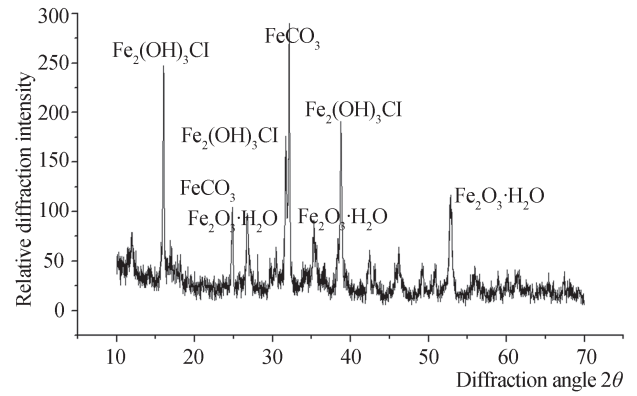
Figure 6
XRD Analysis Spectrum of the Corrosion Fouling Picture of 100 m Depth

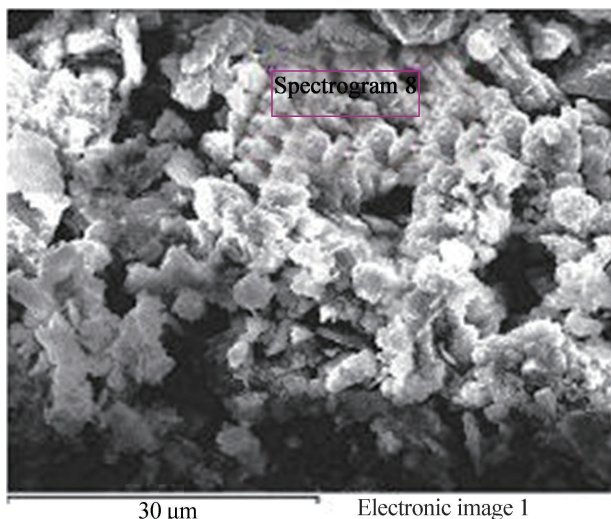
Figure 7
SEM Picture of Corrosion Fouling of 500 m Depth

The results show that the main element in the corrosion fouling is C and O, Fe and Ca follow. XRD analysis spectrum is adapted, and it can be analyzed that the corrosion product of 500 m depth are mainly Fe_9S_8 , $CaCO_3$ and $FeCO_3$, which is shown in Figure 8.

So we can safely come to the conclusion that the main cause of the casing corrosion of 500 m depth is SRB, the reasons are as follows: (a) The temperature of 100 m to 1,000 m depth is about 30 to 40 Celsius degree, which falls in the limits that fits the build-up and reproduce of SRB; (b) The S elements of the Energy spectrum analysis are not from crude oil; (c) The Fe_9S_8 found in XRD analysis spectrum is one of the classic products of SRB corrosion.

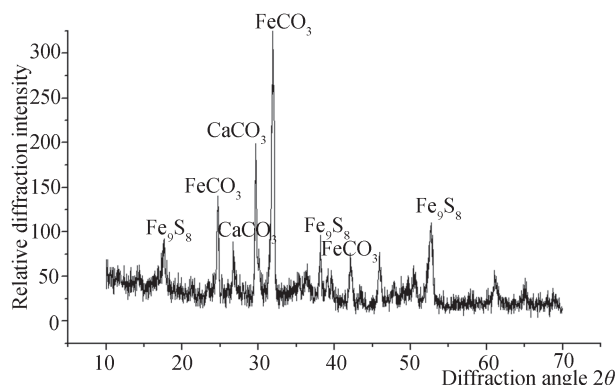
Figure 8
XRD Analysis Spectrum of the Corrosion Fouling Picture of 500 m Depth

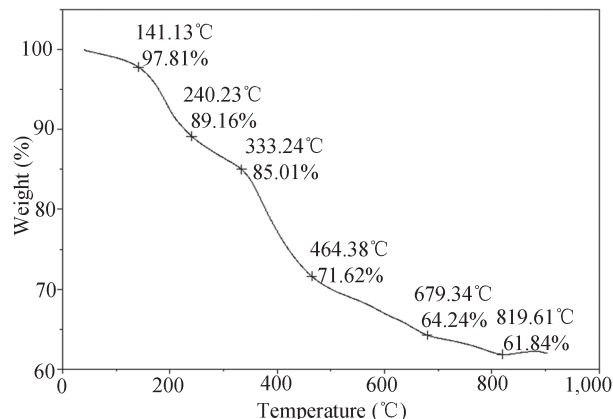
Figure 9
TGA Analysis of the Corrosion Fouling Picture of 500 m Depth

After analyzing of TGA analysis results, it can be easily seen that there are two temperature weightless intervals: 141.3-240.23 °C and 333.24-464.36 °C. They respectively correspond to the hydrate decomposition and the decomposition of $FeCO_3$. Besides, there are some twists and turns in the curve which indicates various compounds in the sample.

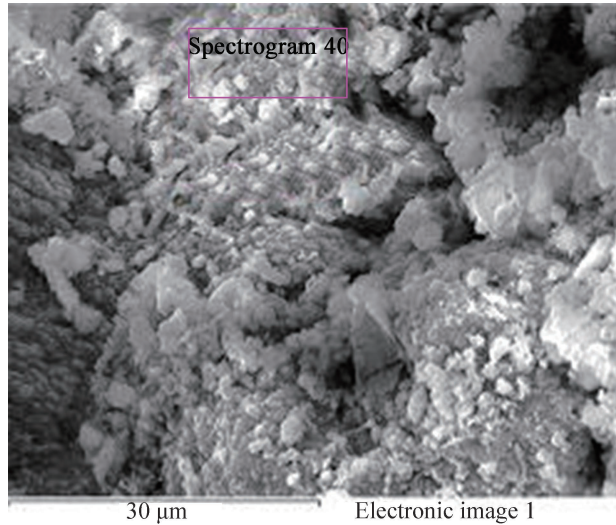
analyzed with SEM observation and Energy spectrum analysis and the results are shown in Figure 10 and Table 4. From Table 4 we can see that the main elements in the corrosion fouling are still C, O and Fe. The result of XRD analysis spectrum shows that the corrosion product is mainly $(Ca,Mn)CO_3$ (Figure 11), it also indicates serious scale deposit in this injecting well. The existence of CO_3^{2-} indicates that CO_2 corrosion is the main reason for the casing corrosion in this layer.

Figure 10
SEM Picture of Corrosion Fouling of 1,500 m Depth

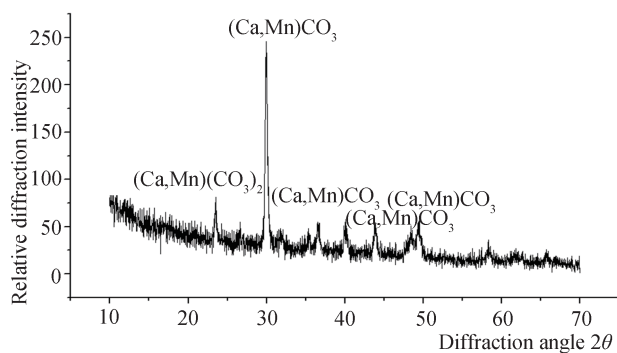
Figure 11
XRD Analysis Spectrum of the Corrosion Fouling Picture of 1,500 m Depth

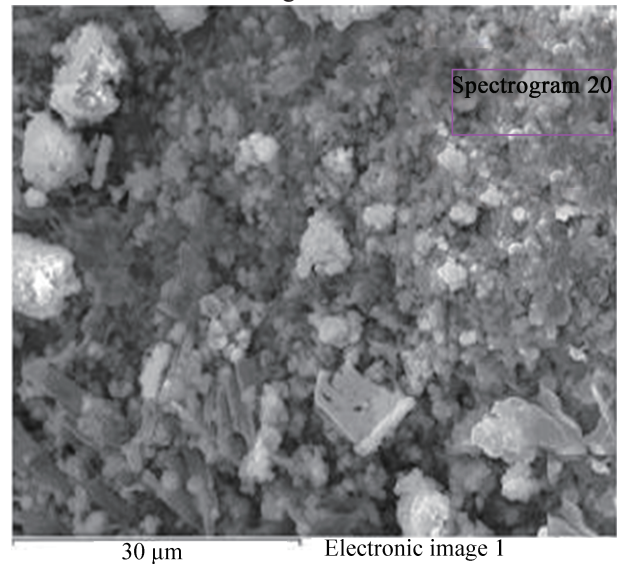
Figure 12
SEM Picture of Corrosion Fouling of 2,100 m Depth

The results show that the main elements in the corrosion fouling are orderly C, O, Fe, S and Cl. Of all of them, C and O are much more, which indicates the corrosion product is mainly carbonate. XRD analysis spectrum and TGA analysis are practiced on the corrosion fouling and the results are shown in Figures 13 and 14. The results show that the corrosion product is mainly $FeCO_3$. It also shows that casing corrosion in this layer is mainly resulting from CO_2 corrosion.

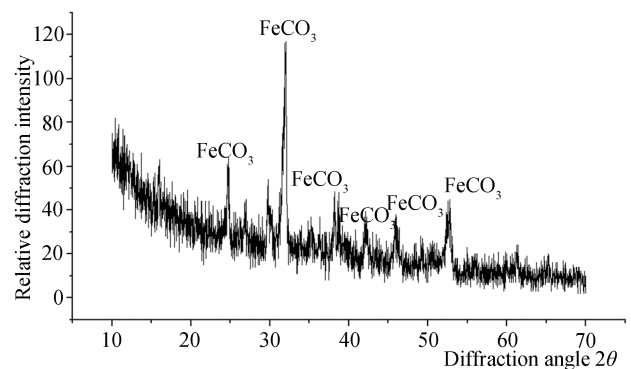
Figure 13
XRD Analysis Spectrum of the Corrosion Fouling Picture of 2,100 m Depth

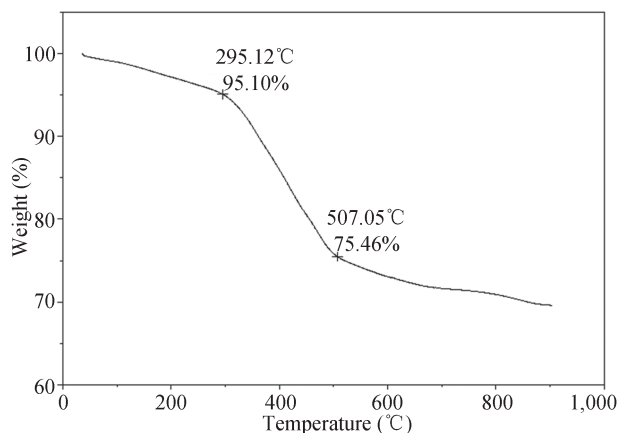
Figure 14
TGA Analysis the Corrosion Fouling Picture of 2,100 m Depth
